**FINAL RECOMMENDATIONS REPORT:**

Upper Barwon, Yarrowee and Leigh rivers FLOWS study update

May 2019

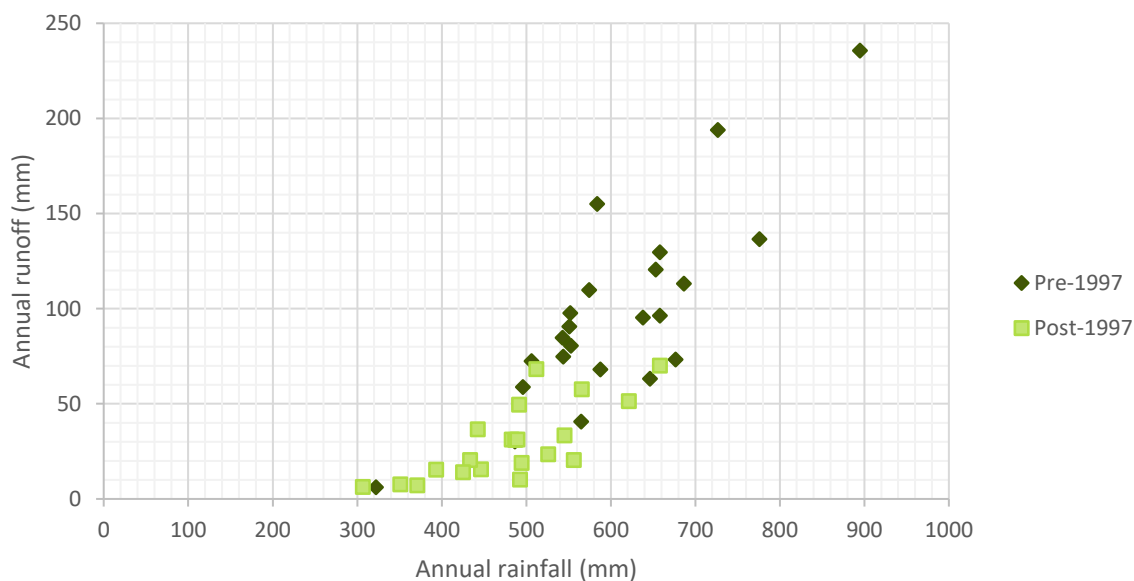
A similar narrative is presented in the larger Barwon River downstream of its confluence with the Leigh River (233200 Barwon River at Pollocksford - Figure 9). An apparent step-change in average rainfall inputs of approximately 20% has led to a decrease in average runoff by 69%.

**Figure 9.** Relationship between annual rainfall and runoff for the Barwon River (233200 Birregurra Creek at Pollocksford) for the years 1974-2017

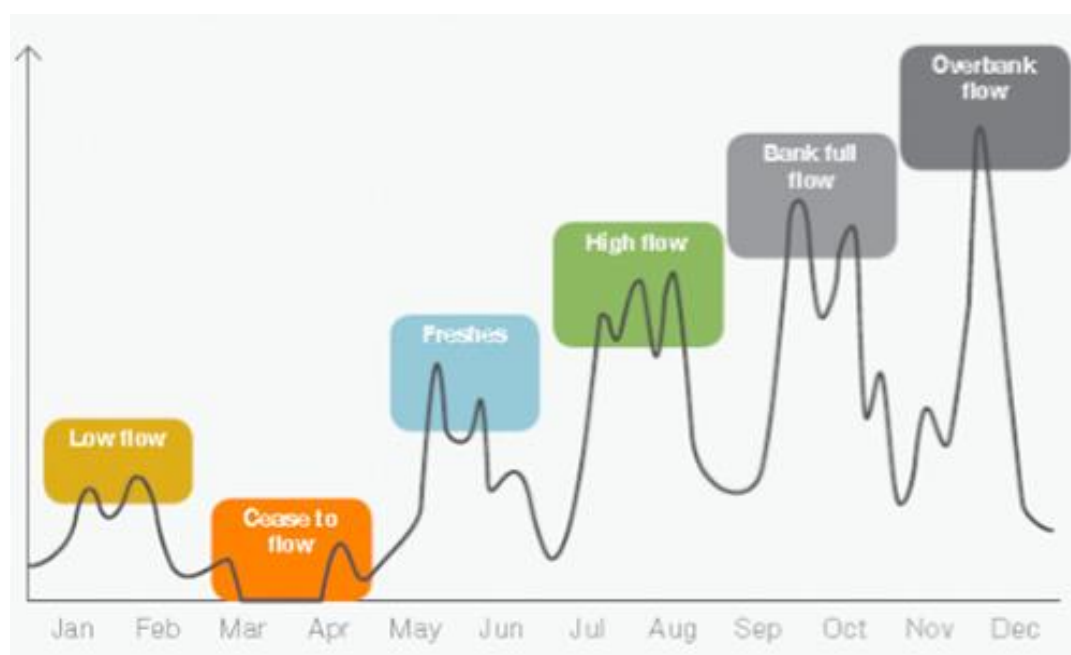
The FLOWS method requires recommendations to be made for a number of different flow components (Figure 12 and Table 3). Each component has a known or assumed important environmental function, although the method is generic for Victoria, we have selected flow components that are important or critical for the reaches of the Barwon River included in this study. The Environmental Flows Technical Panel assesses which flow components based on the suite of species present (or previously present) and their requirements in each reach.

**Figure 12.** Visual representation of the FLOWS method flow components (DSE, 2007) Note that terminology differs from that adopted throughout this study (see Table 3).

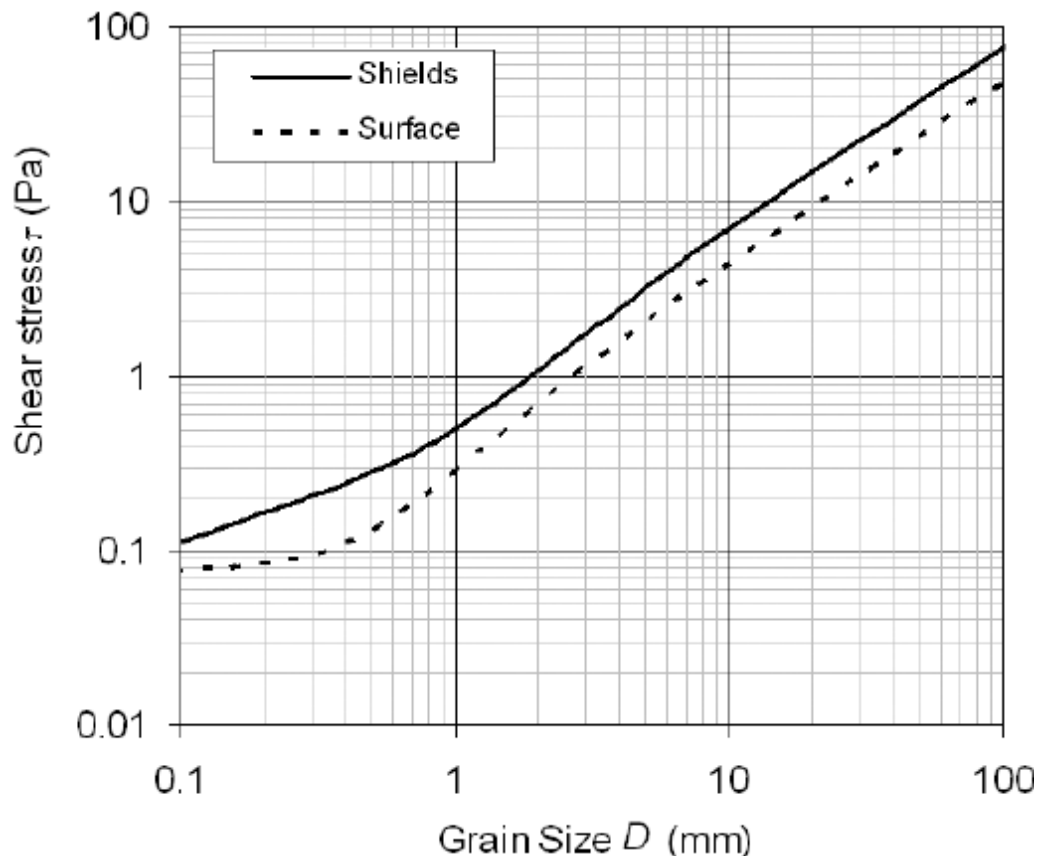
For the purpose of this study, a shear stress of  $0.1 \text{ N/m}^2$  has been adopted as that necessary to mobilise silts ( $0.1\text{mm}$  diameter) and  $1.0 \text{ N/m}^2$  for the mobilisation of fine sand ( $1\text{mm}$  diameter).

**Figure 22.** Shields Curve in dimensional space (from Wilcock *et al.*, 2009)

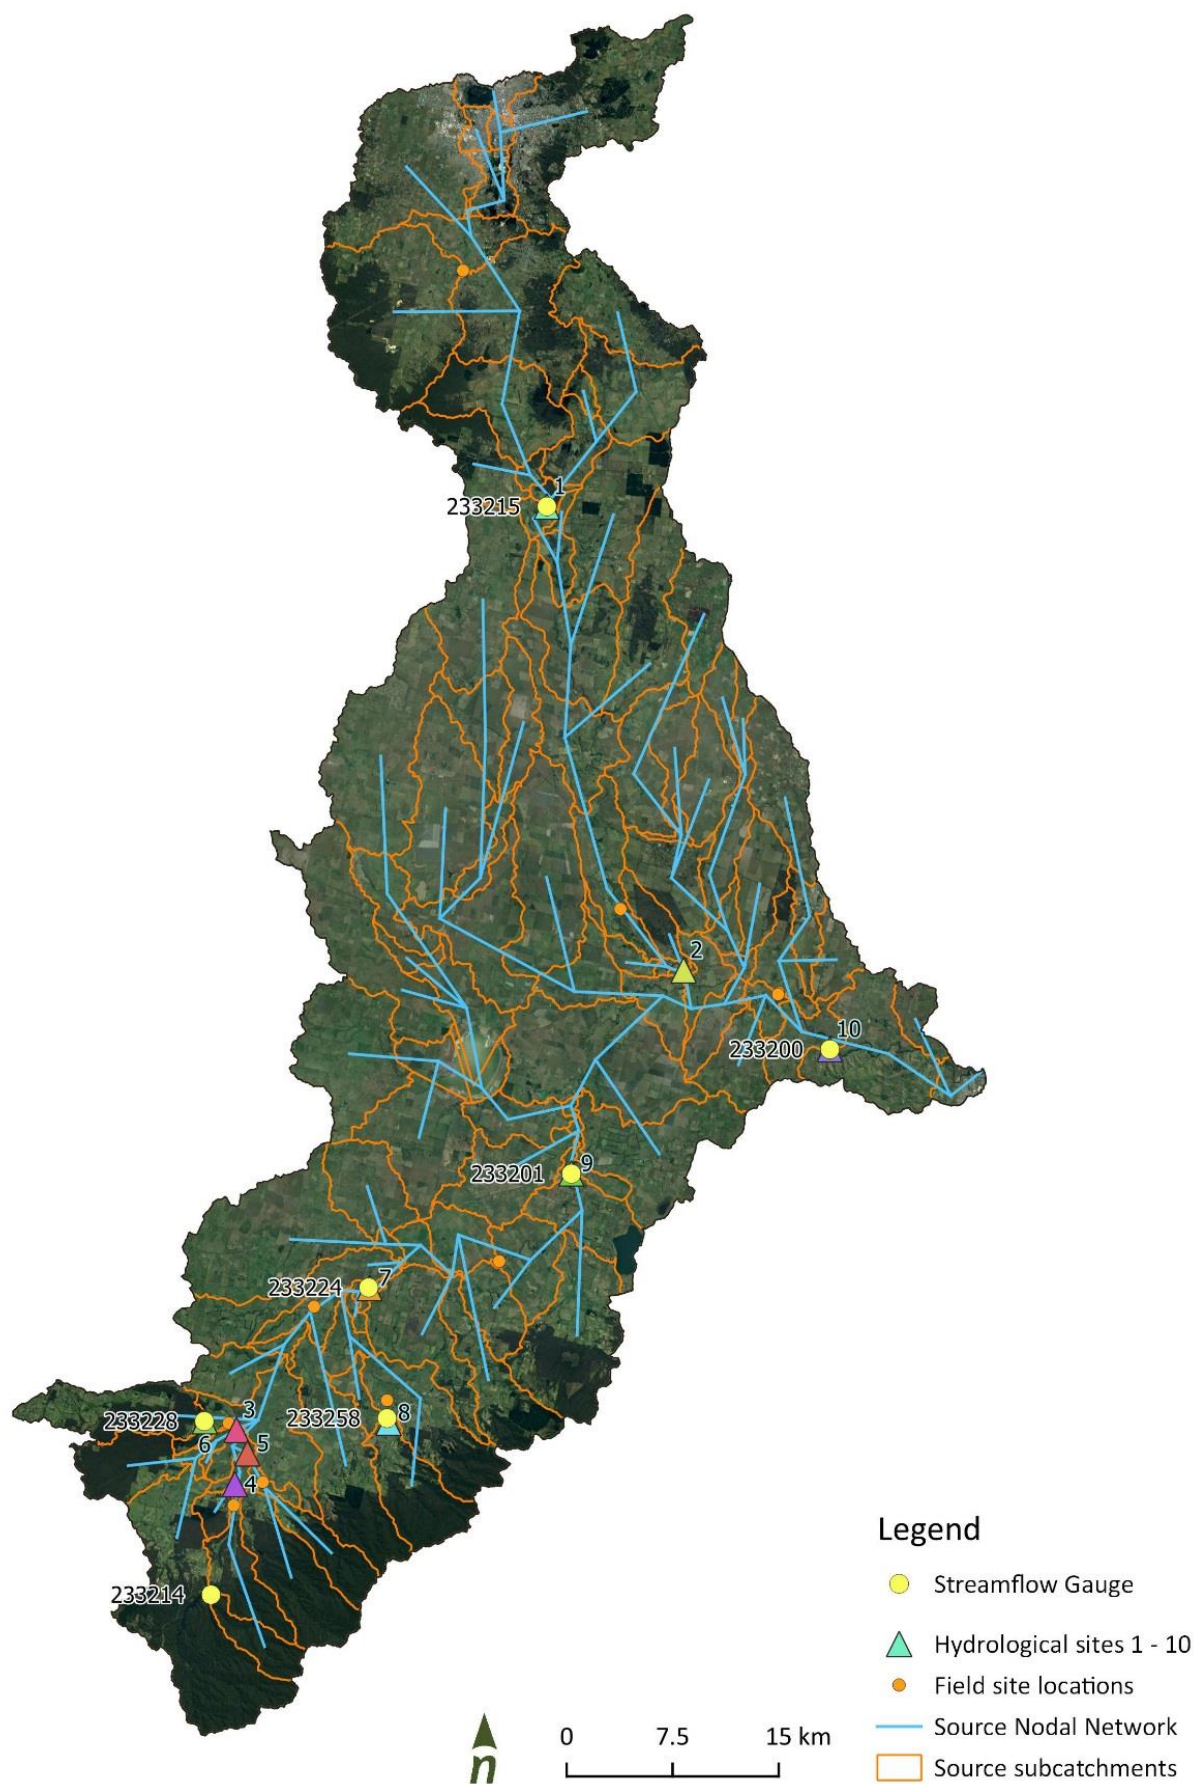
**Figure 29.** Overview of the Source catchments model developed for the Barwon system
